**CONSENT ORDER
ISSUED UNDER THE
WATER POLLUTION CONTROL ACT
WEST VIRGINIA CODE, CHAPTER 22, ARTICLE 11**

TO: Mountain Valley Pipeline, LLC
Attn: Robert J. Cooper
Senior Vice President, Engineering and Construction
625 Liberty Ave, Ste 1700
Pittsburgh, PA 15222

DATE: April 19, 2019

ORDER NO.: 8951

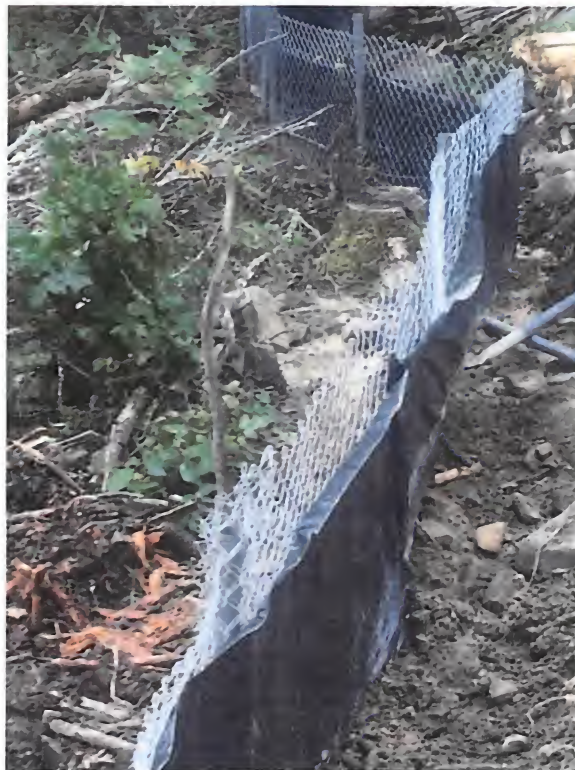
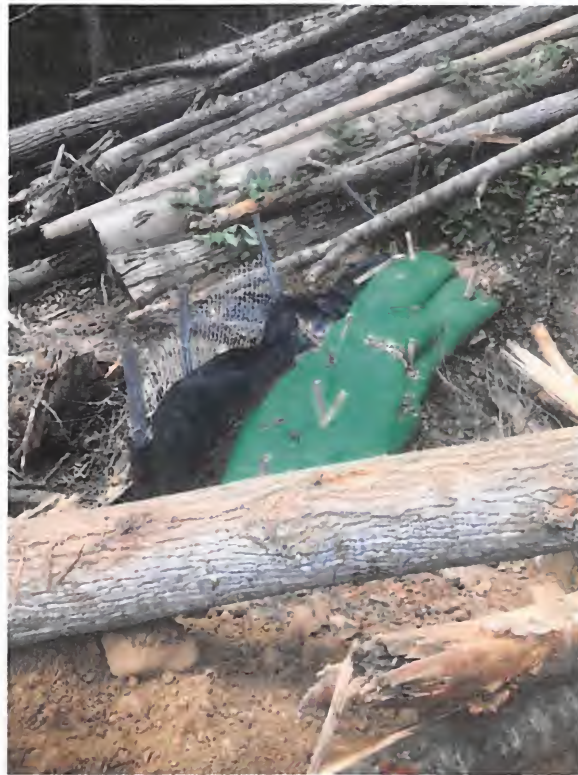
Area near station number 9907+00. Super silt fence had been undermined and damaged by logs.

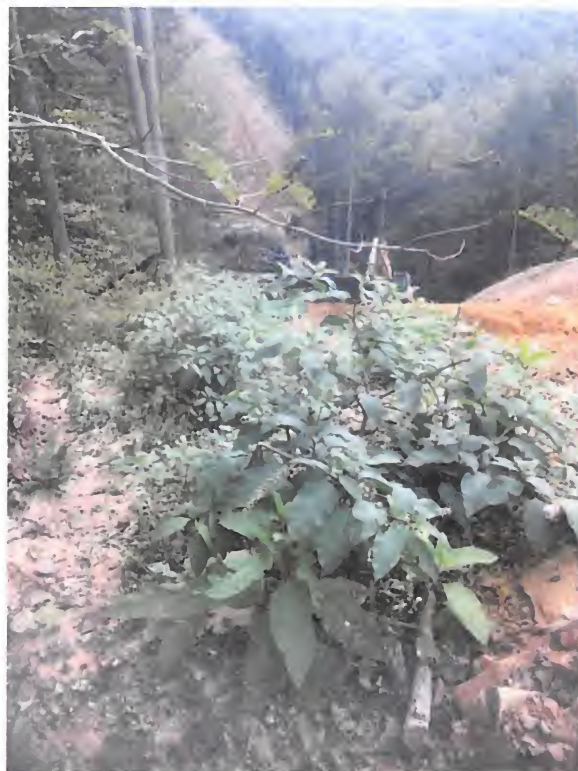
Near Station # 9911+00 where BMP was being overwhelmed and off-site sediment deposits were observed.

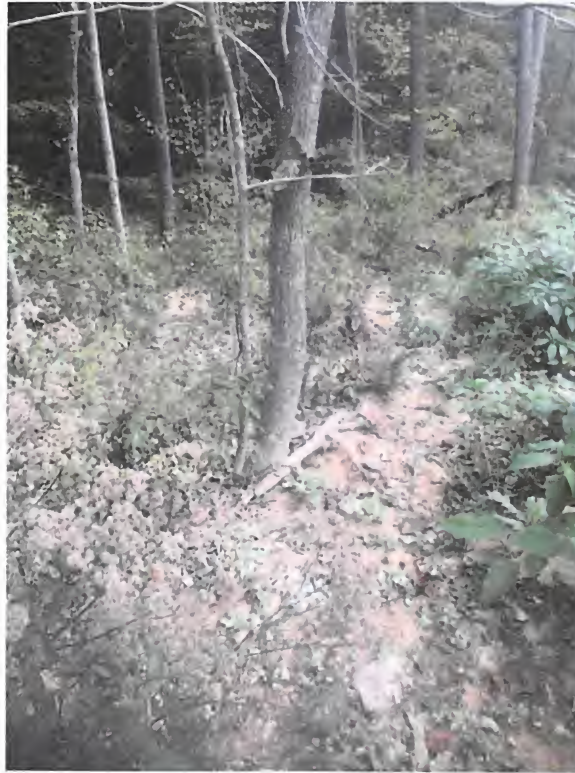
Off-site sediment deposits near station #9911+00.

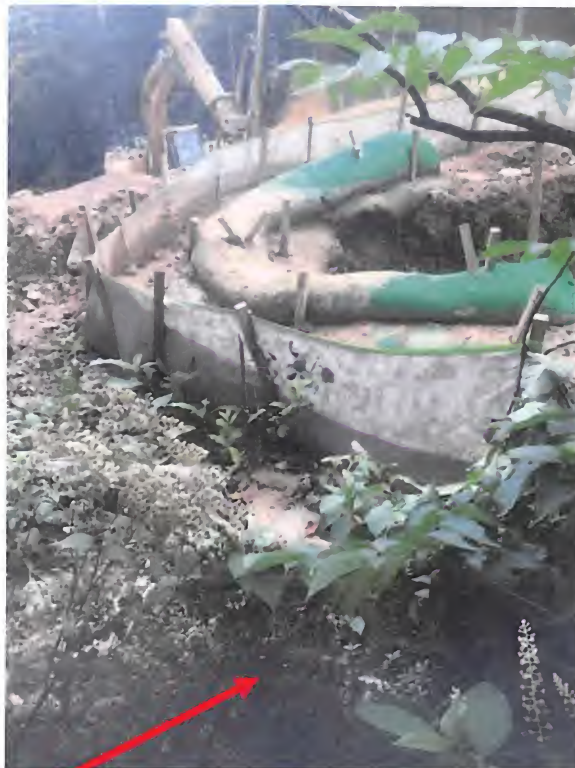
BMP near Station #9911+00 being overwhelmed and sediment flowing under and through control. Arrow depicts where sediment laden water was leaving BMP.

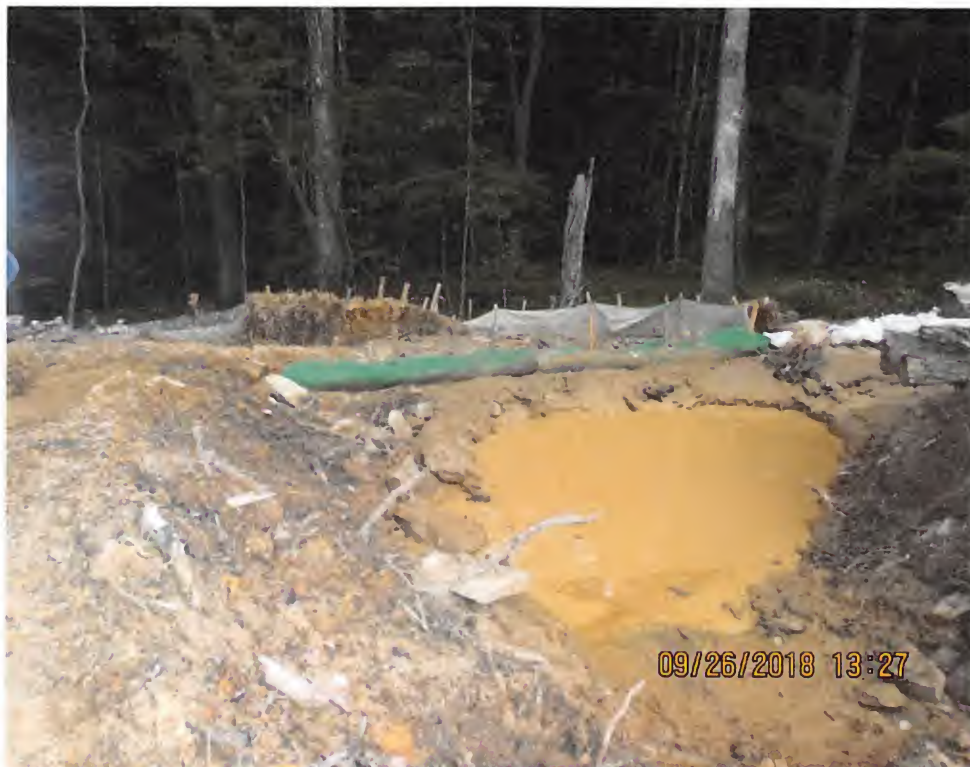
Waterbar terminus near being overwhelmed near Station #9899+00.

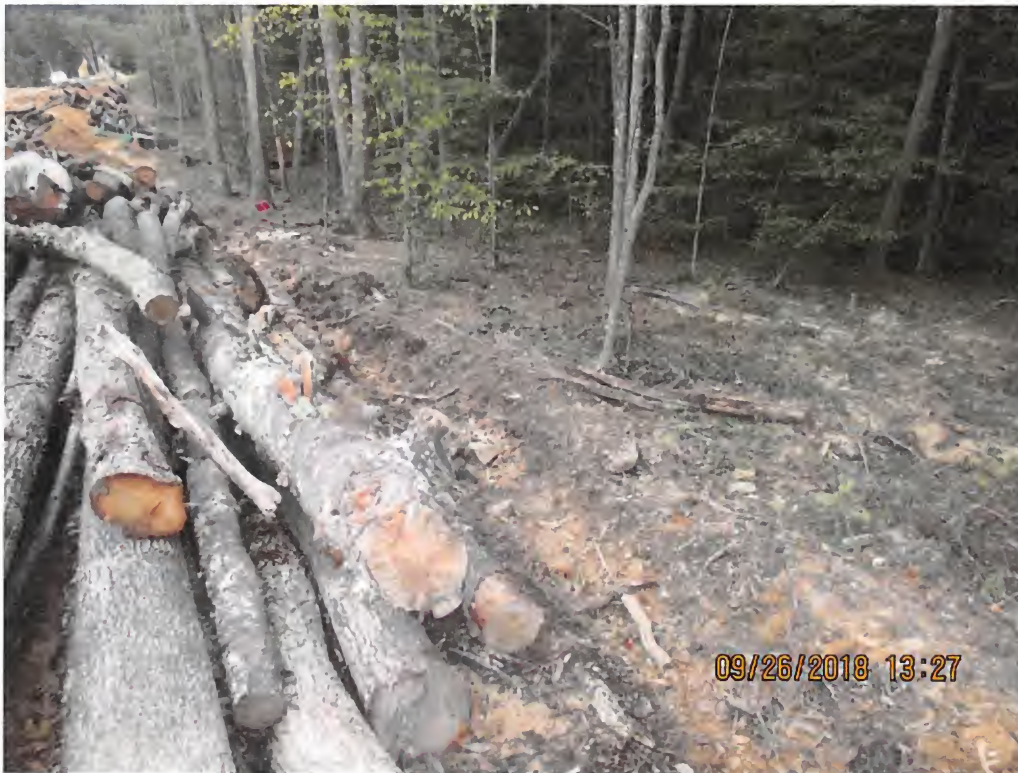
Off-site sediment deposits near Station number 9899+00.

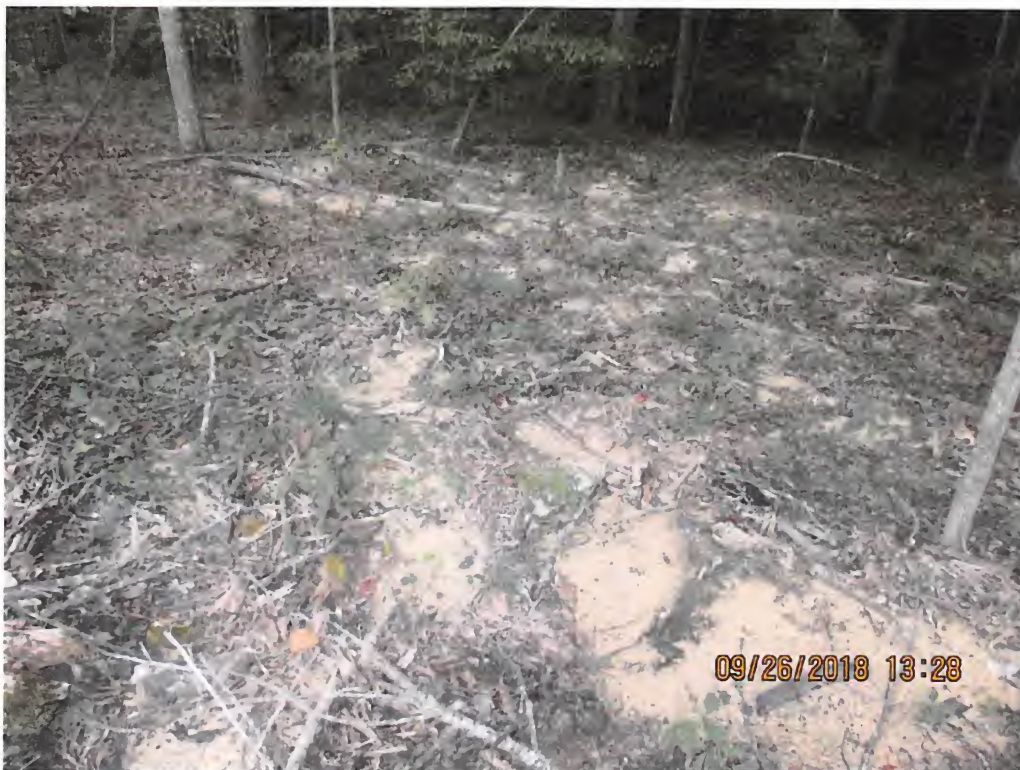
Off site sediment deposits located past LOD and being transported towards Streams S-H58 and TTWV-S-E58 near Station number 9899+00.

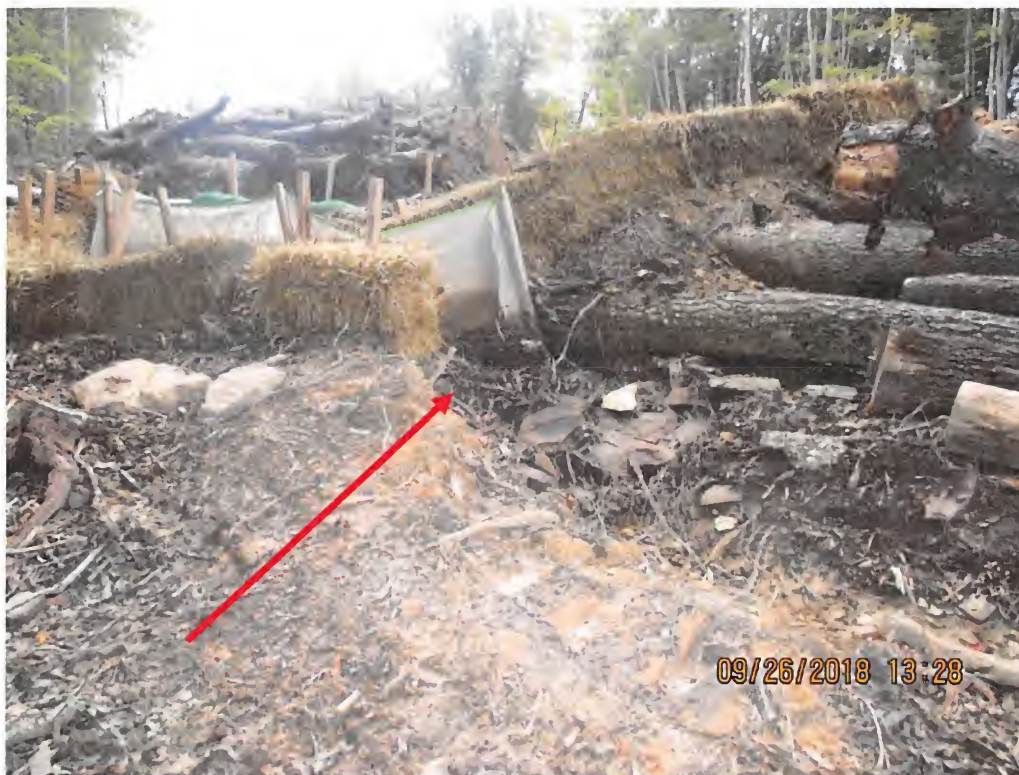
Arrow depicts where BMP was being undermined near Station number 9899+00.

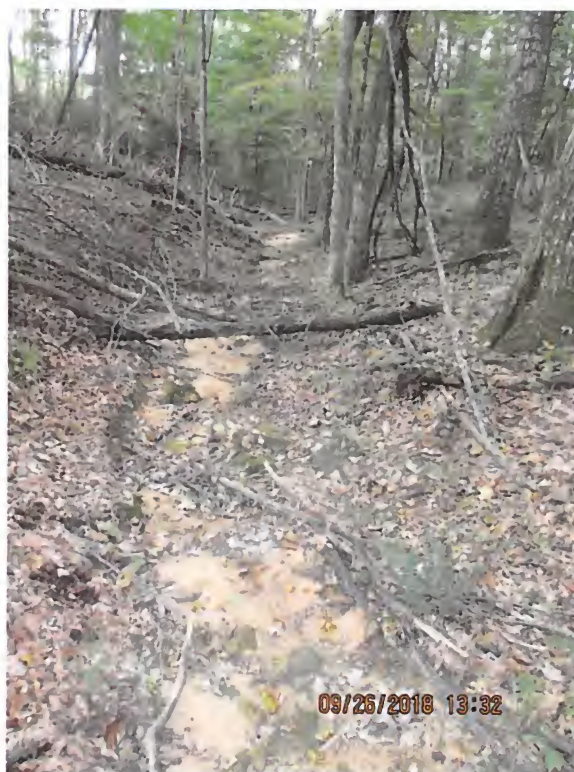
Stream S-H58/TTWV-S-E58 with sediment deposits heading towards Hans creek between Station number 9892+00 through 9899+00.

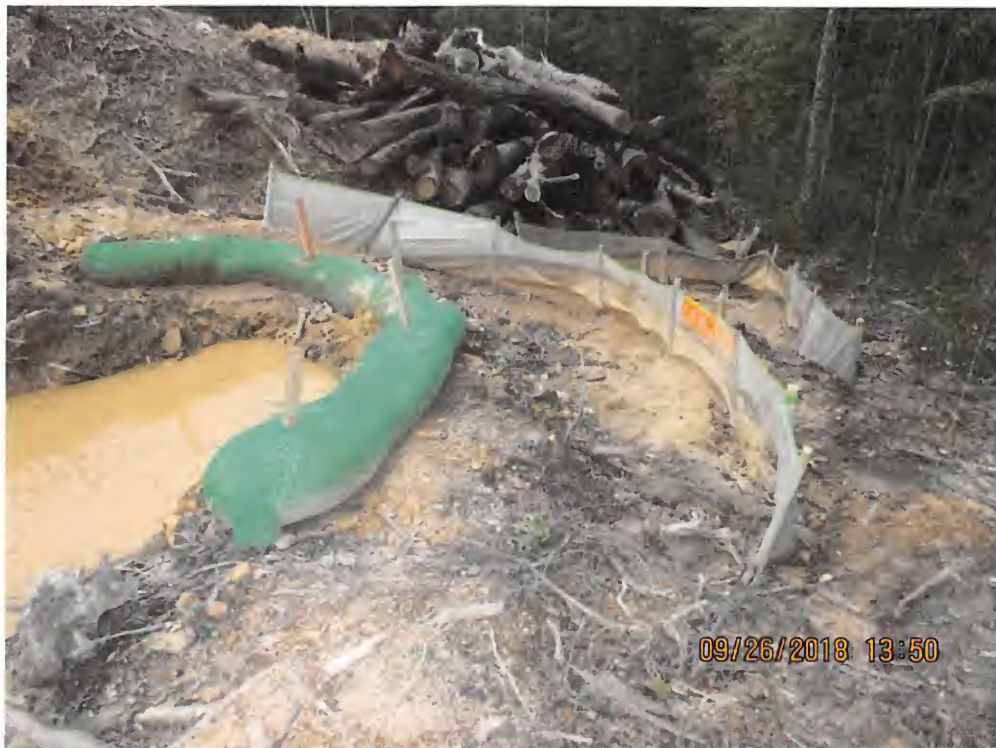
Stream S-H58/TTWV-S-E58 further downhill walking towards Hans Creek near Station number 9897+00.

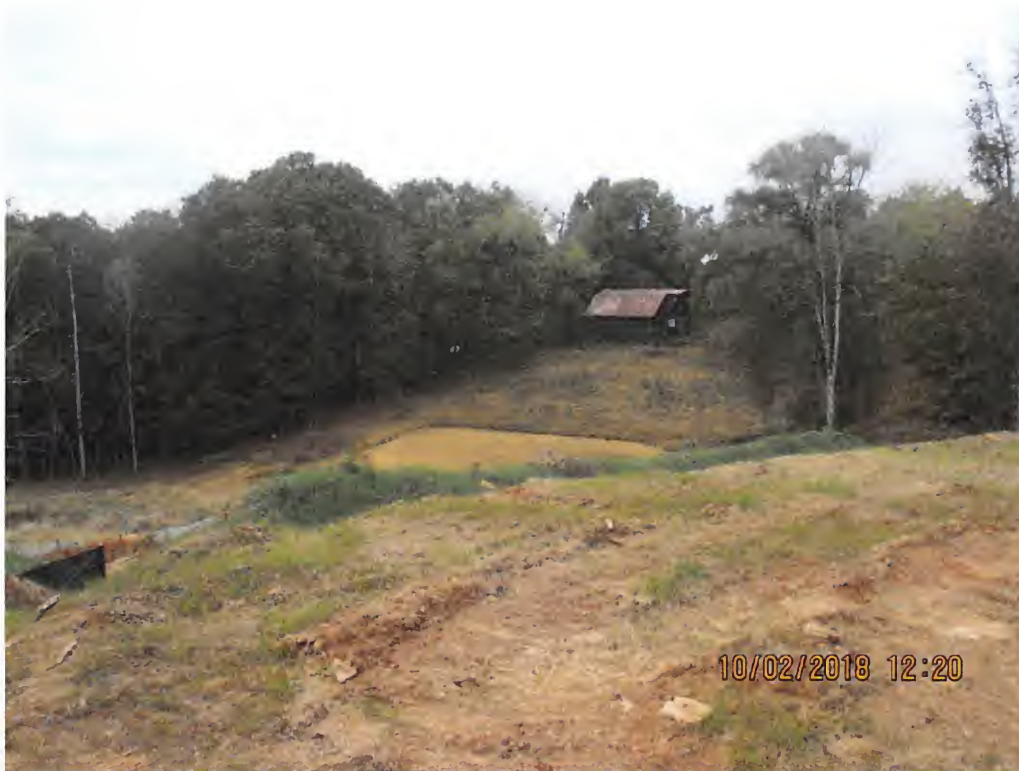
BMP at Station number 9908+00 being overwhelmed where off-site sediment deposits were present past the LOD.

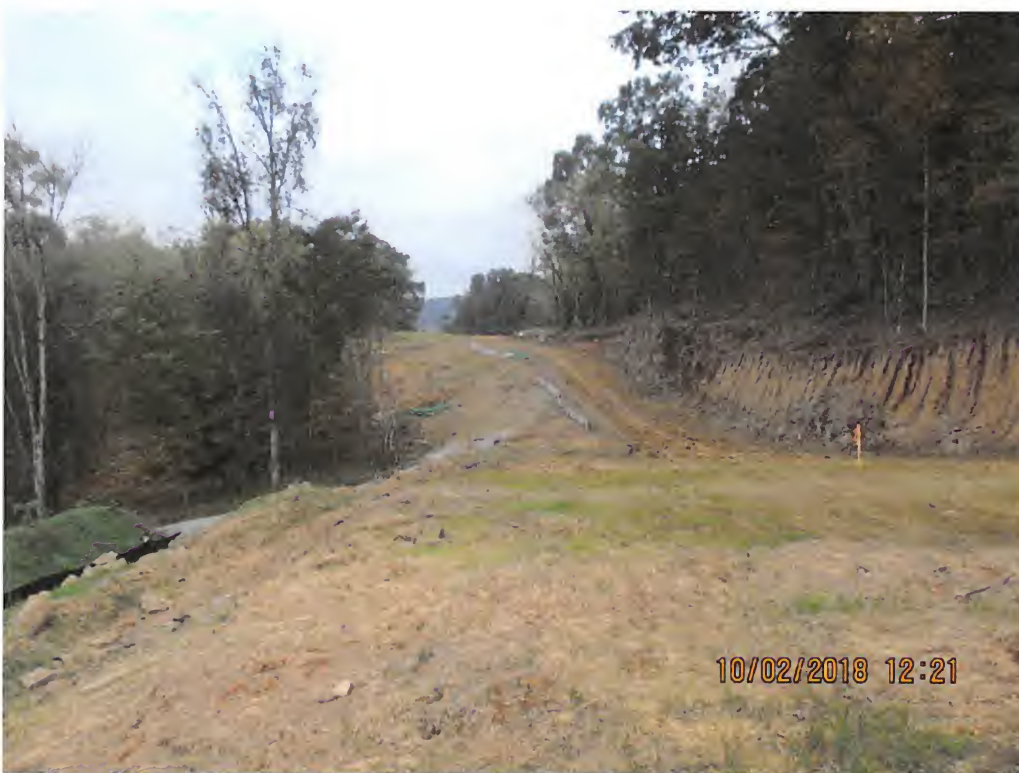
Pond (P-D1) impacted by visible settleable solids.

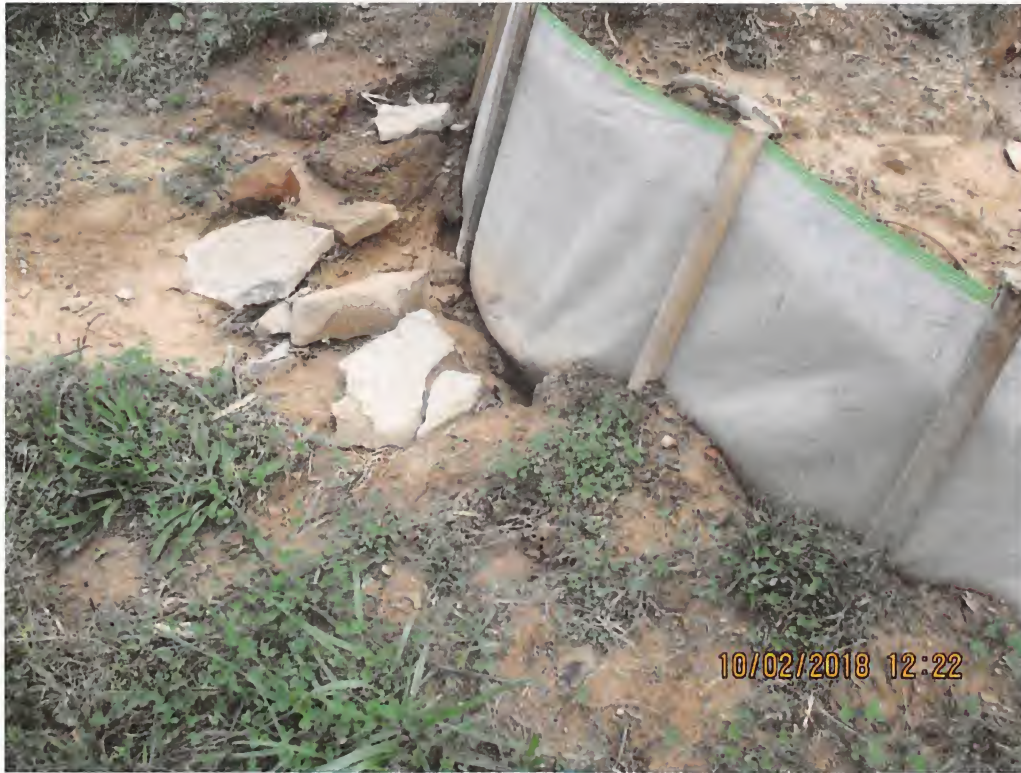
Above mentioned BMP being undercut from run-off.

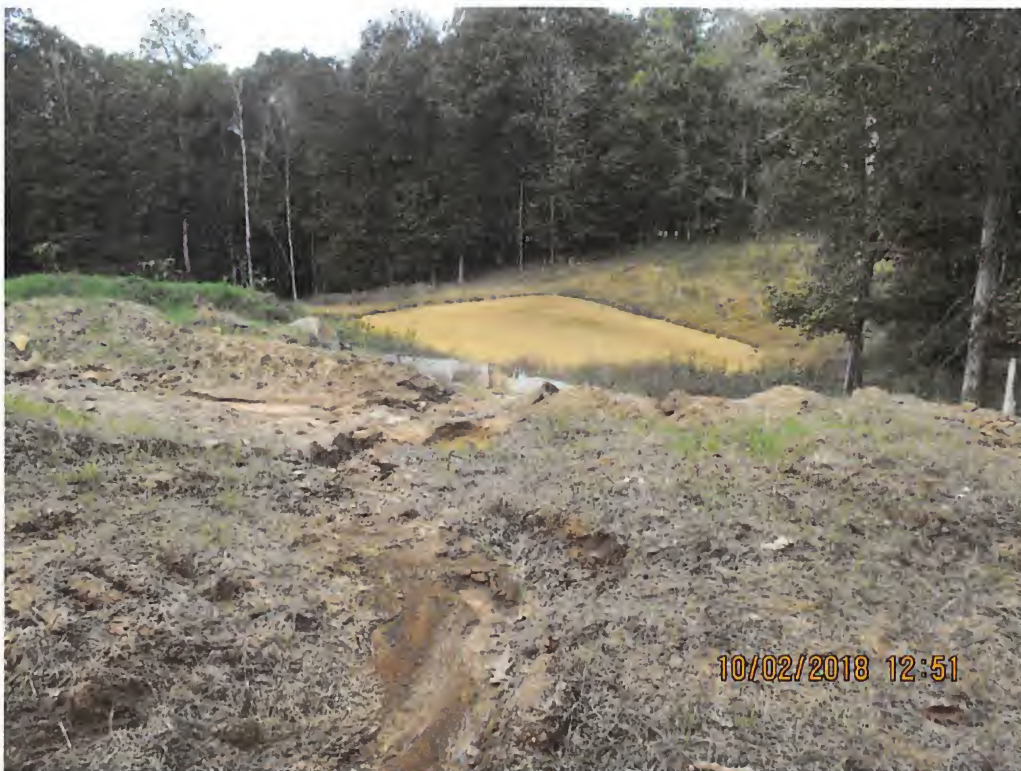
Gully erosion occurring near Station #9687 and flowing towards Pond (P-D2). BMP pictured was failing and off-site sediment deposits were present past the LOD.

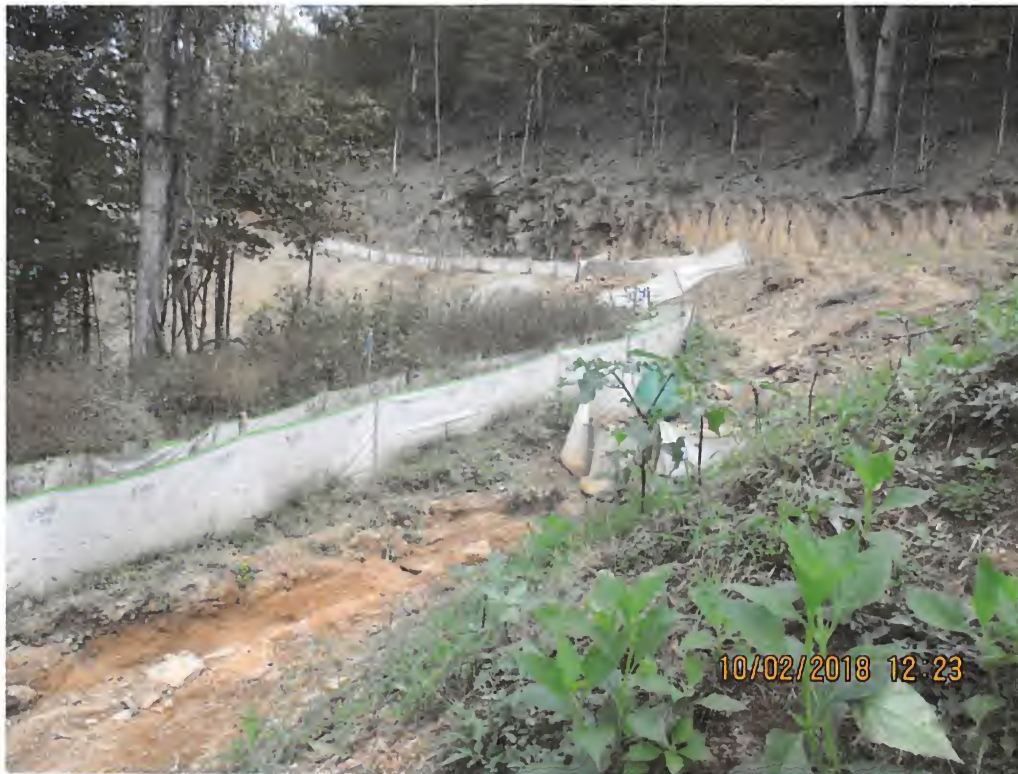
Lack of fill slope protection and channel stabilization enhancing erosion and causing BMP to be overwhelmed at station 9687.

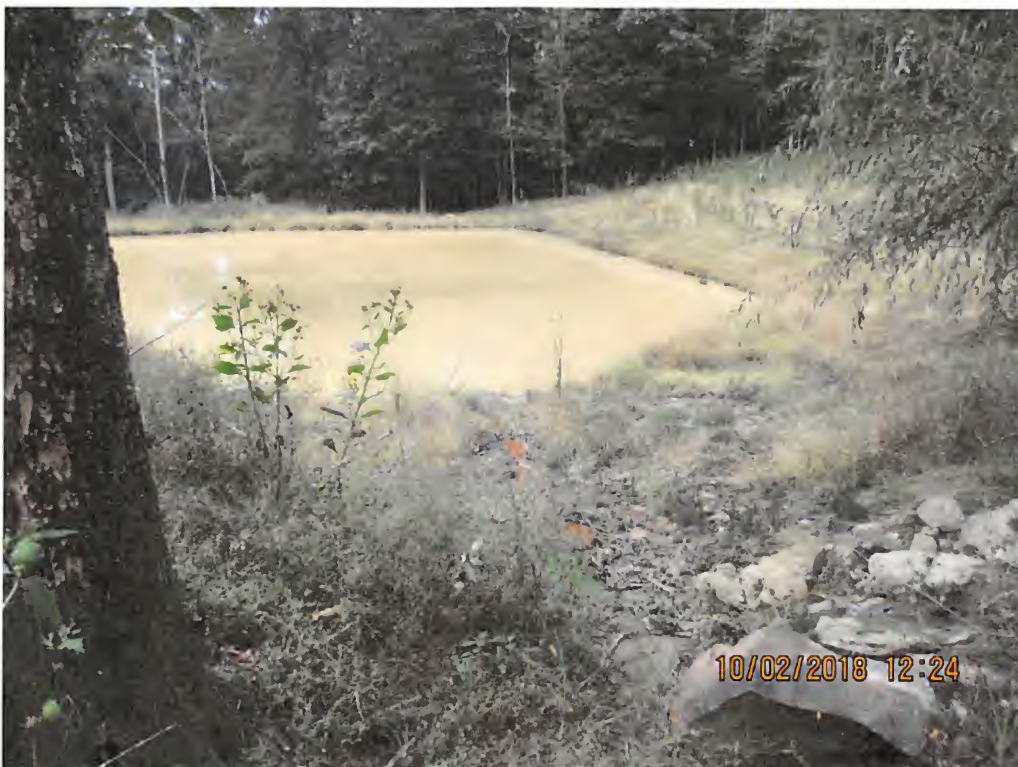
Stream S-D29 leading to Pond P-D1 facing down slope.

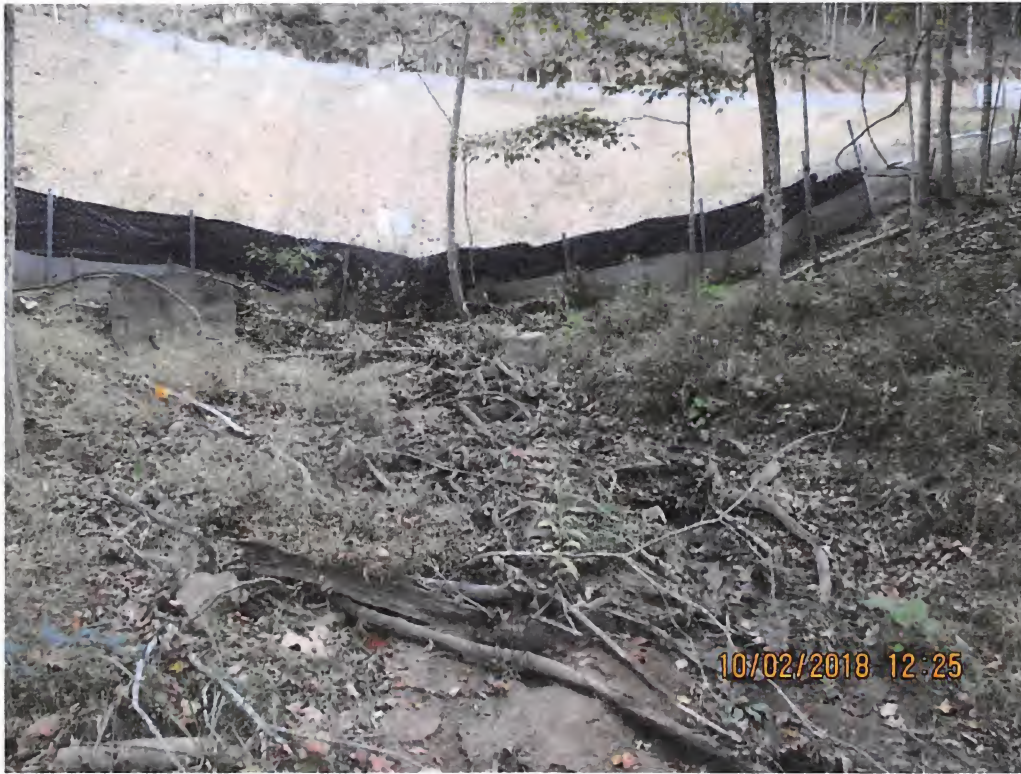
Looking upslope at Stream S-D29 and spring box.

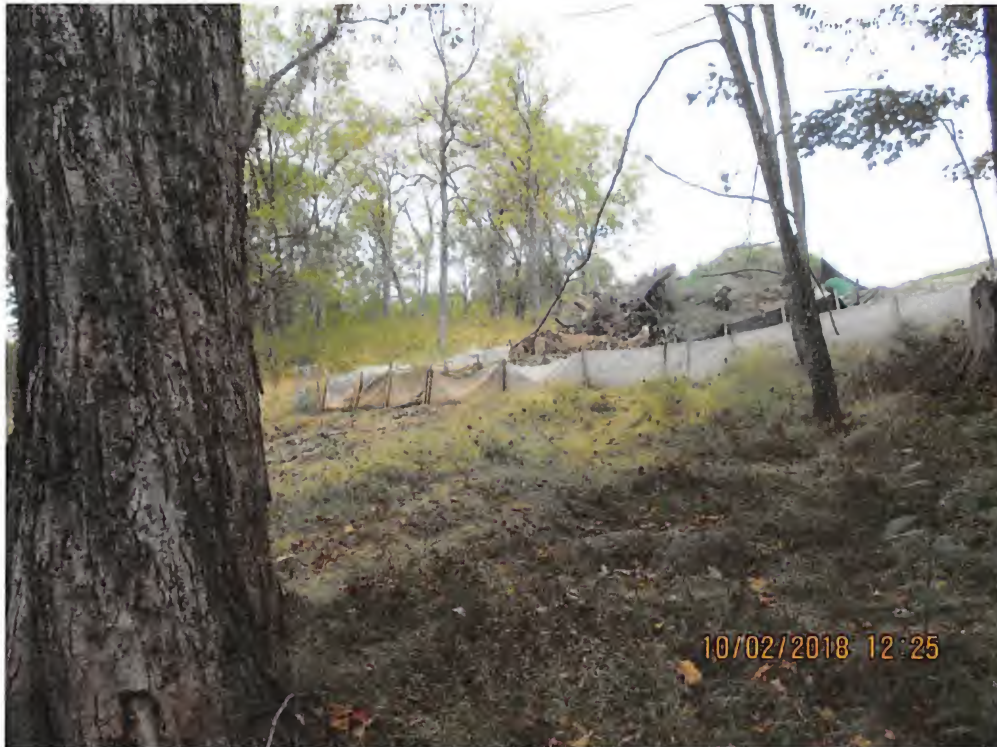
Opposite side of slope where BMP is being overwhelmed.

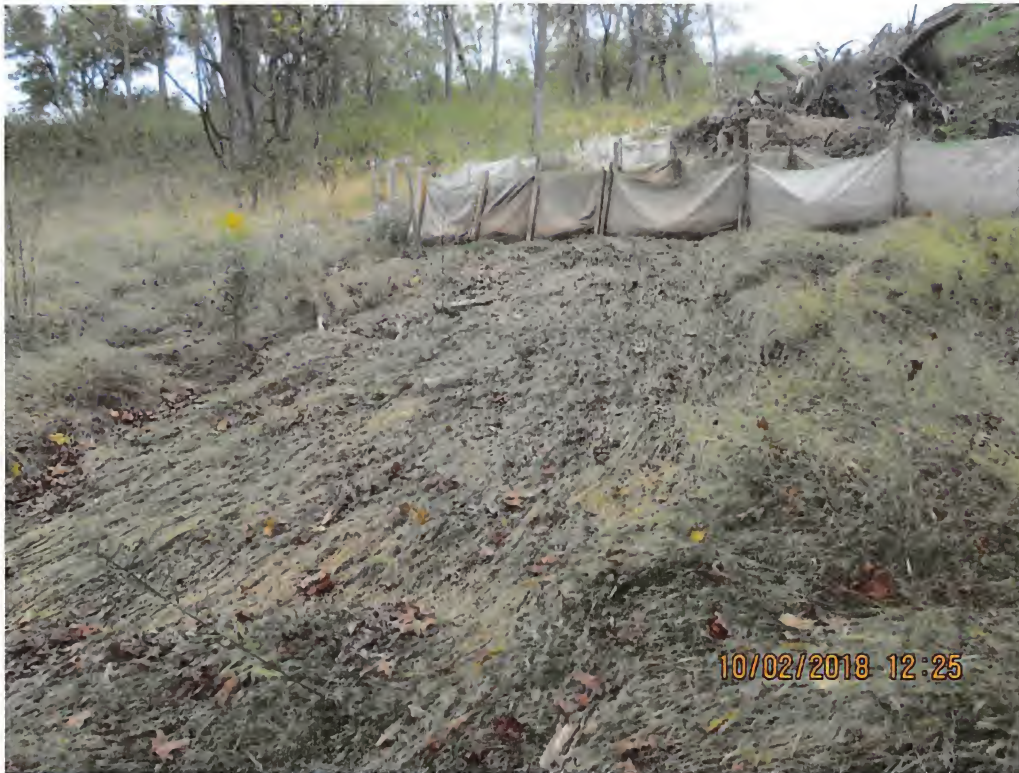
BMP above pond receiving concentrated flow.

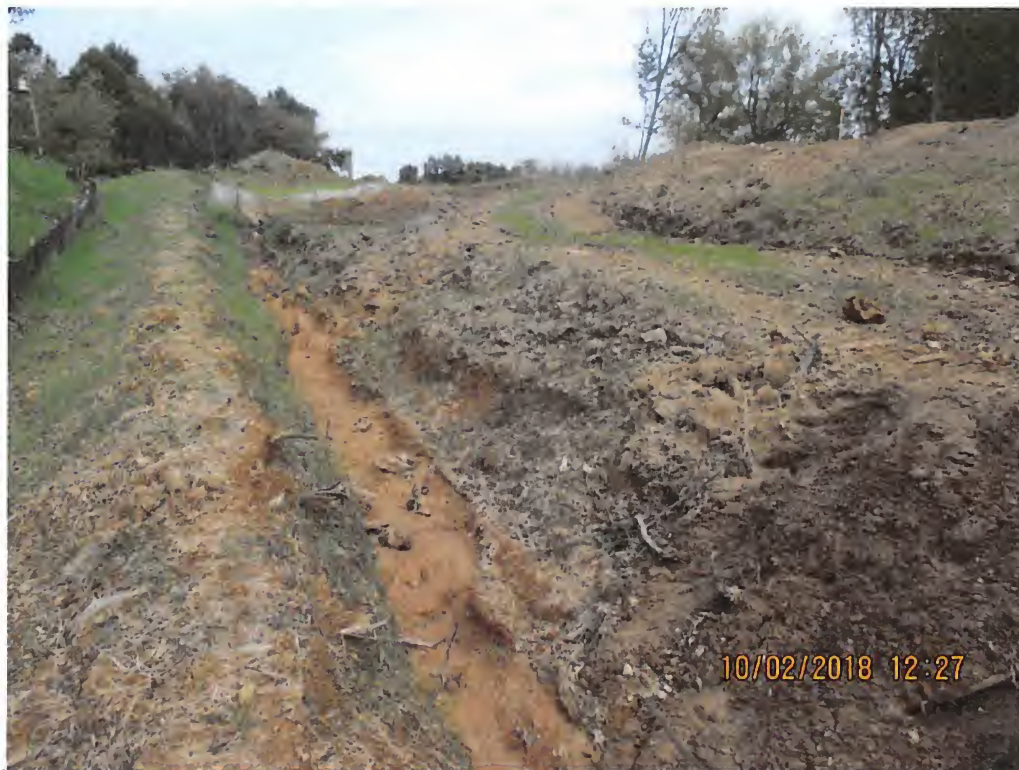
Un-stabilized channel flowing towards above mentioned BMP at station #9687.

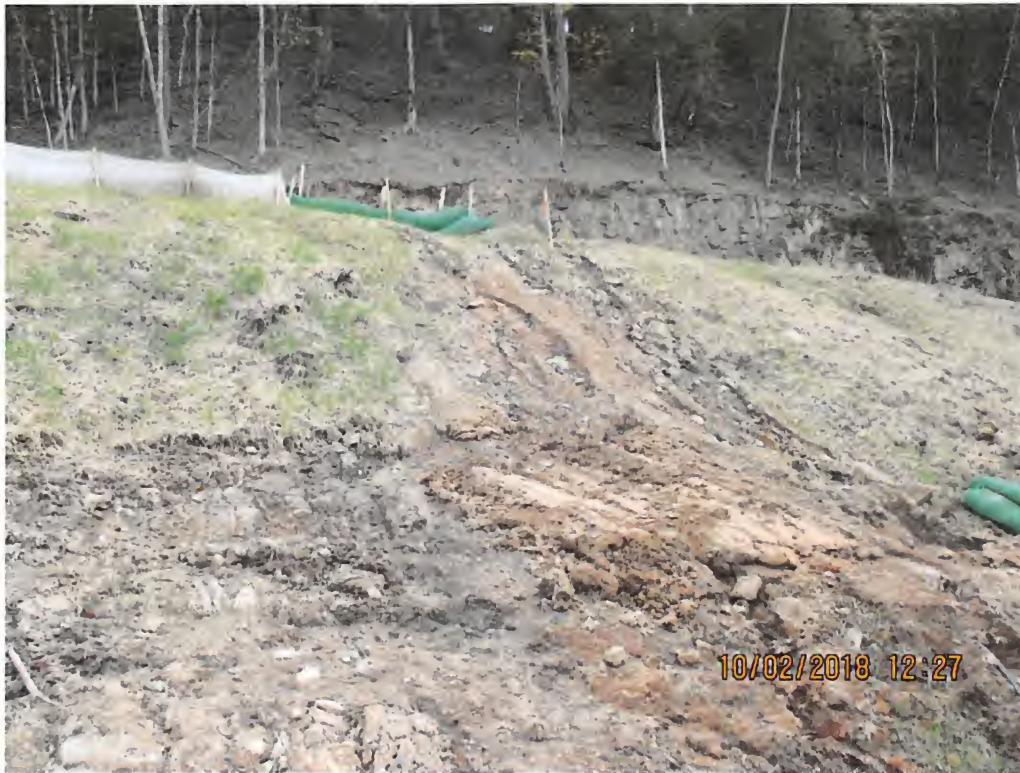
Lack of fill slope protection on opposite side of pond facing upslope near Station #9687.

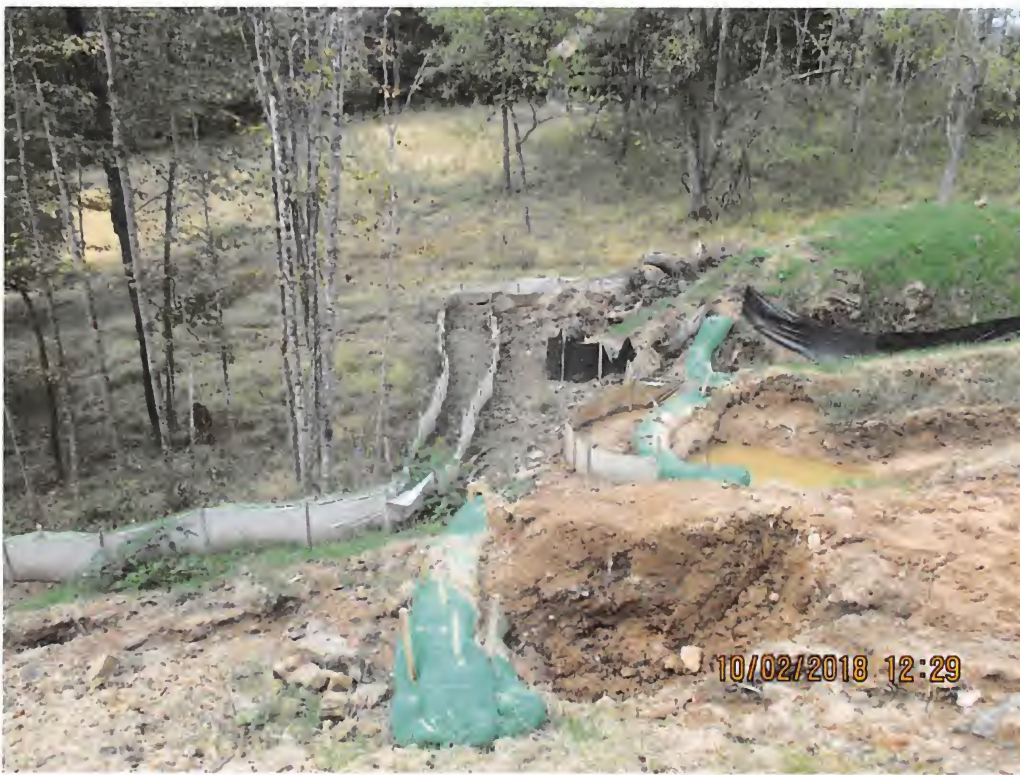
Overview of BMP's north of pond and near station # 9687.

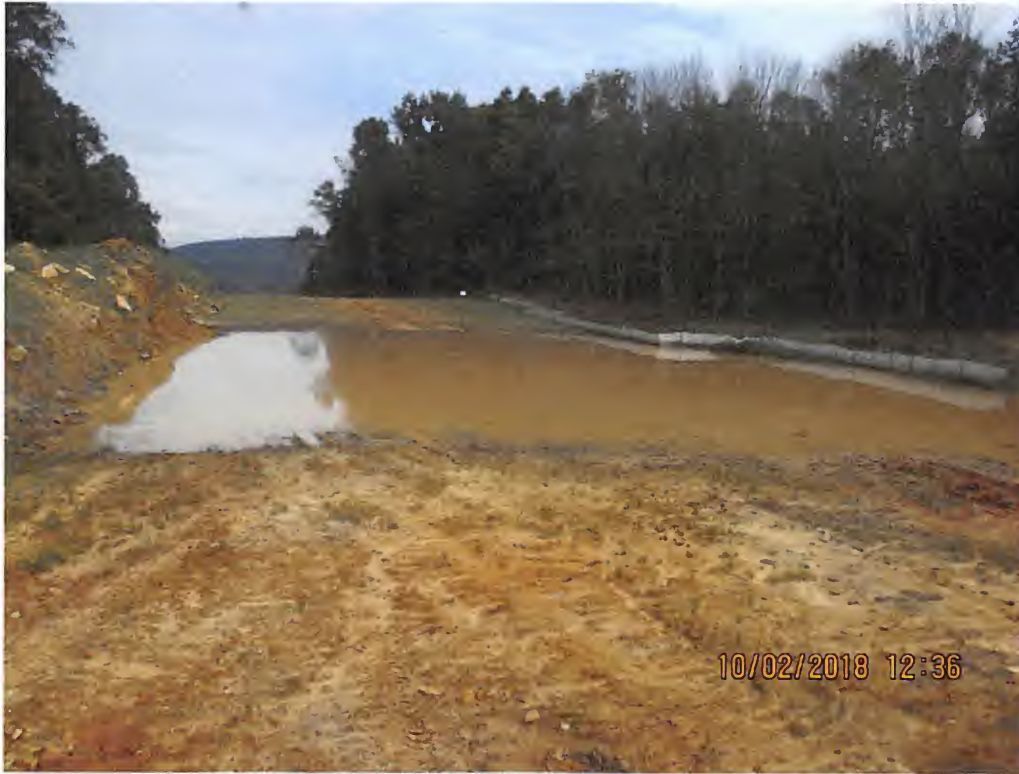
Pond (P-D2) near station number 9680.

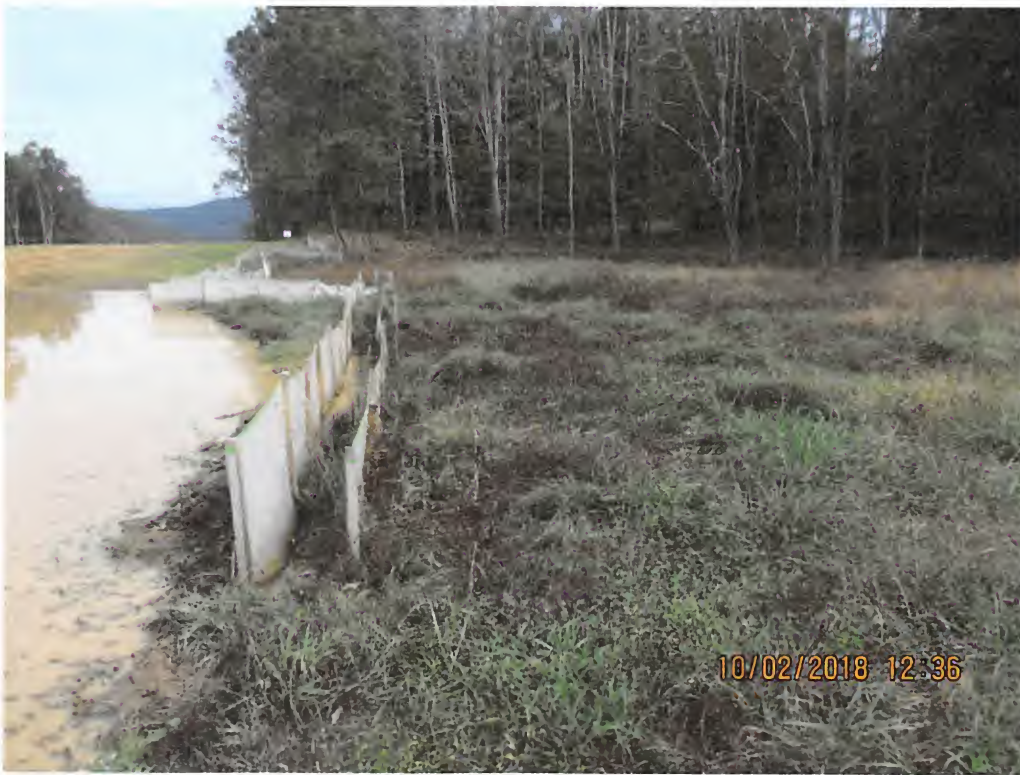
Edge of Pond (P-D2) near station number 9680.

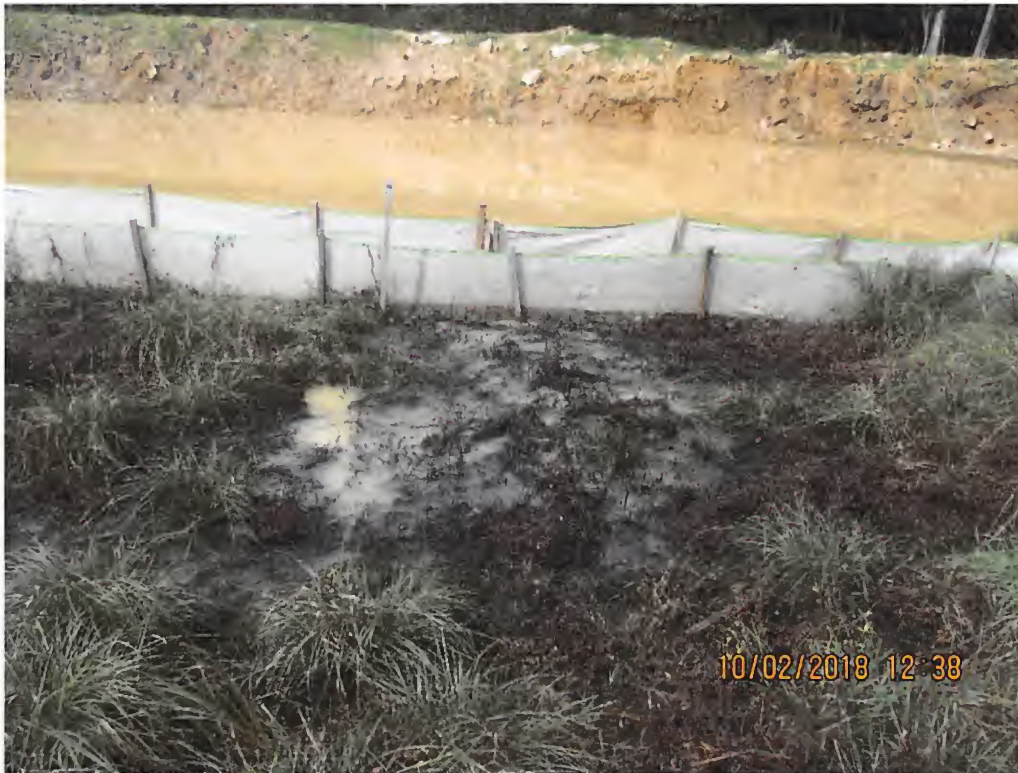
Sediment laden water infiltrating pond P-D2.

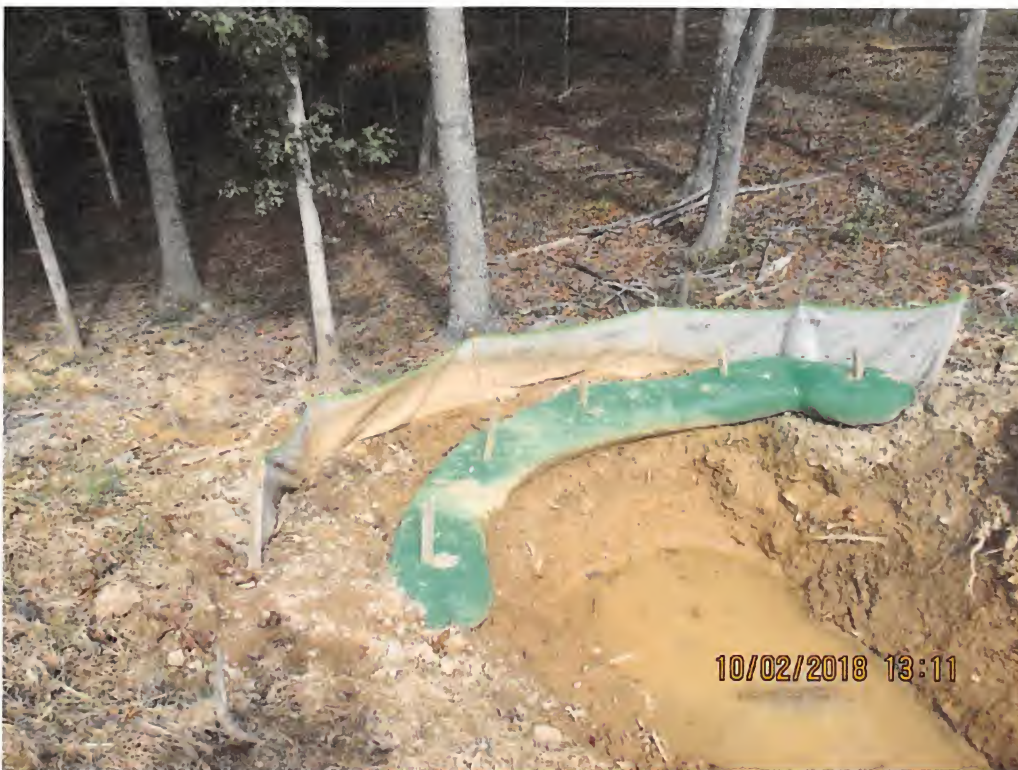
BMP outlet being overwhelmed near station number 9717+52.

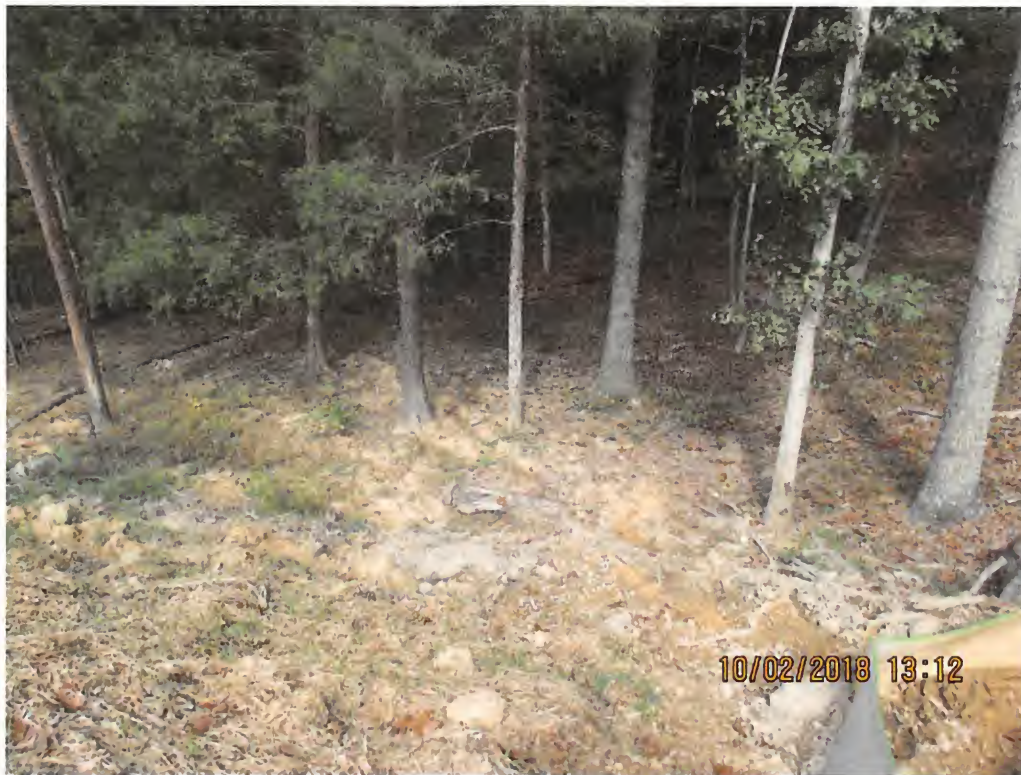
Off-site sediment deposits at Station #9717+52.

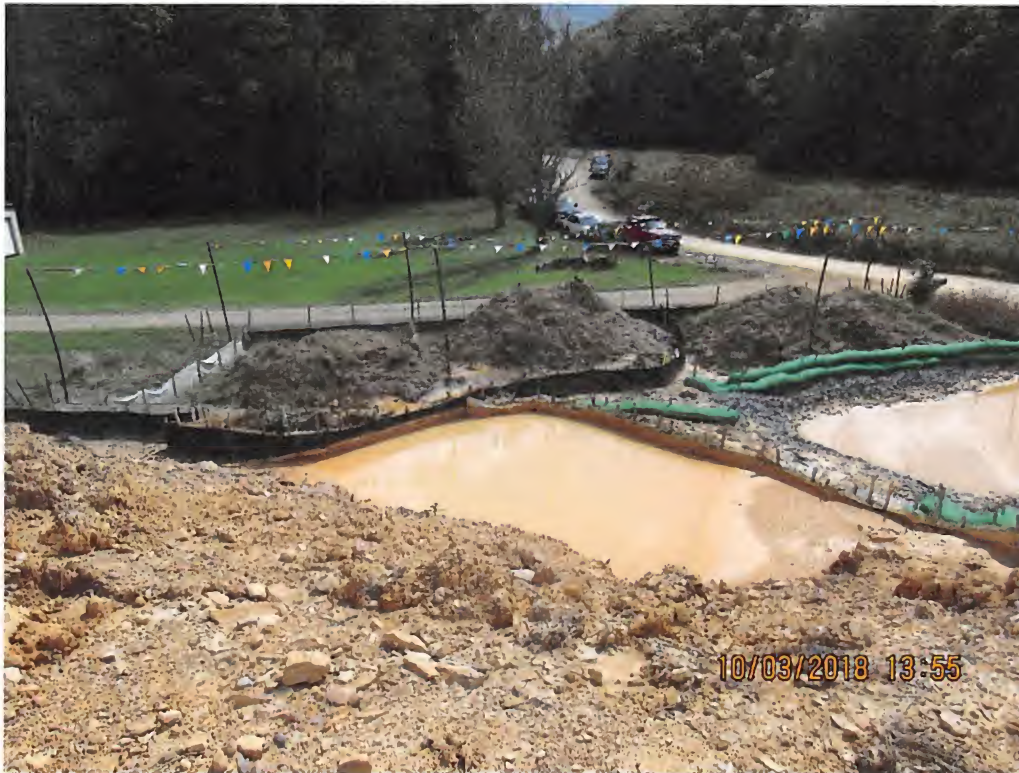
Photo 1: Sump after maintenance performed at Painter's Run Station 10270.

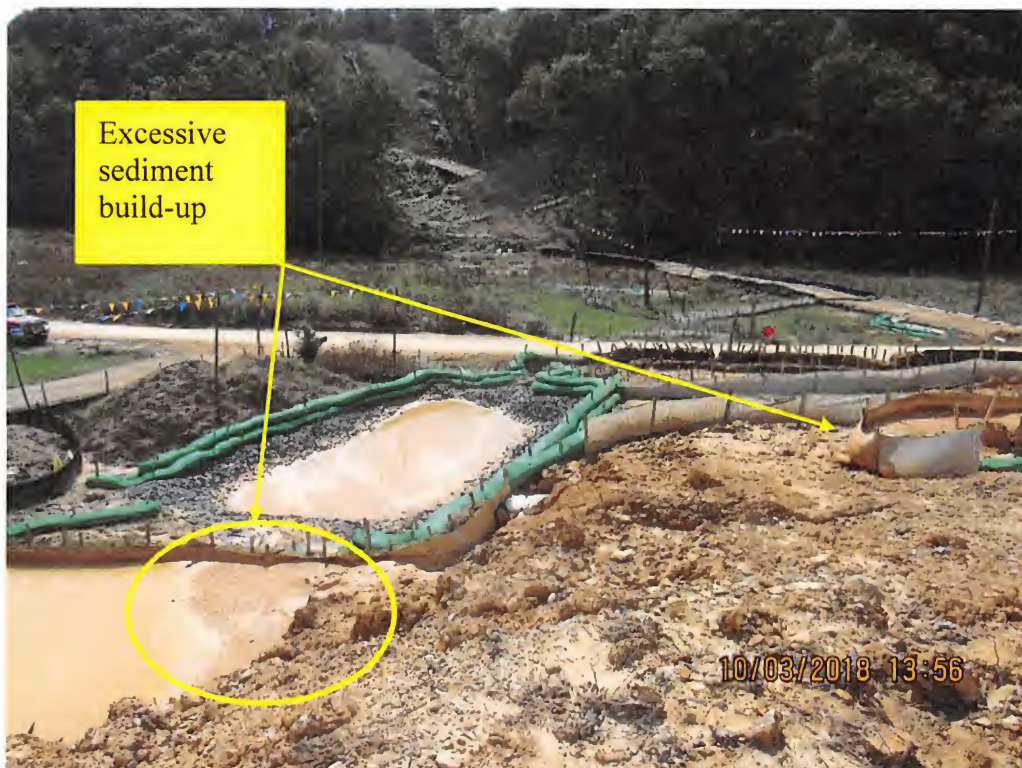
Photo 2: Excessive sediment in sumps after maintenance performed at Painter's Run station 10270.

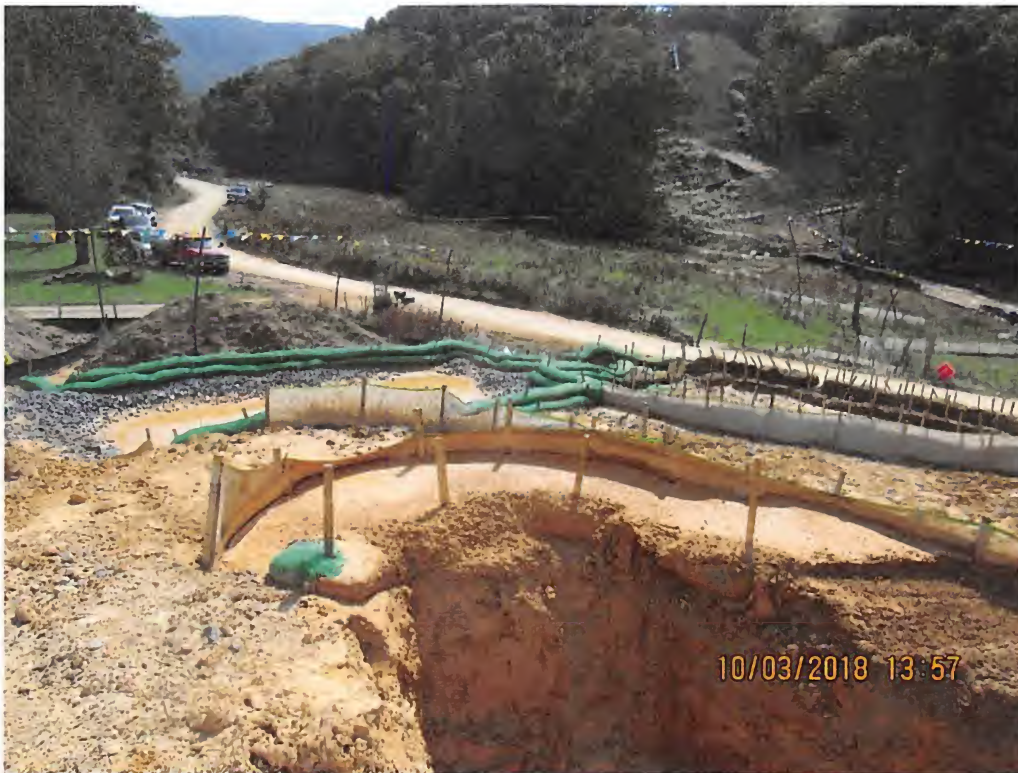
Photo 3: Front of control on right in Photo 2 after maintenance performed at Painter's Run station 10270.
